# TTI Testing Ltd

## Testing of Glen Waters Breakaway snare

Reference number TTI-IMLR-2021-5825

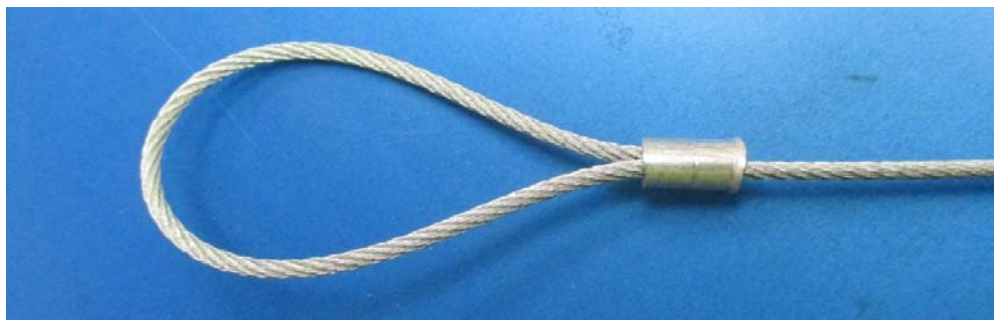
**Figure 4.2:** Swaged eye loop to secure snare to the ground “ground eye loop” (either directly or via a swivel).

The focus of this study was the “Glen Waters Breakaway snare”, three samples of which were supplied by **NASC** for testing. Figure 4.1 shows a general overview of the snare. Figure 4.2 shows the swaged<sup>1</sup> eye loop which would be used to secure the snare to the ground, and Figure 4.3 a detail view of the centre swivel, running eye hardware and assumed breakaway weak link.

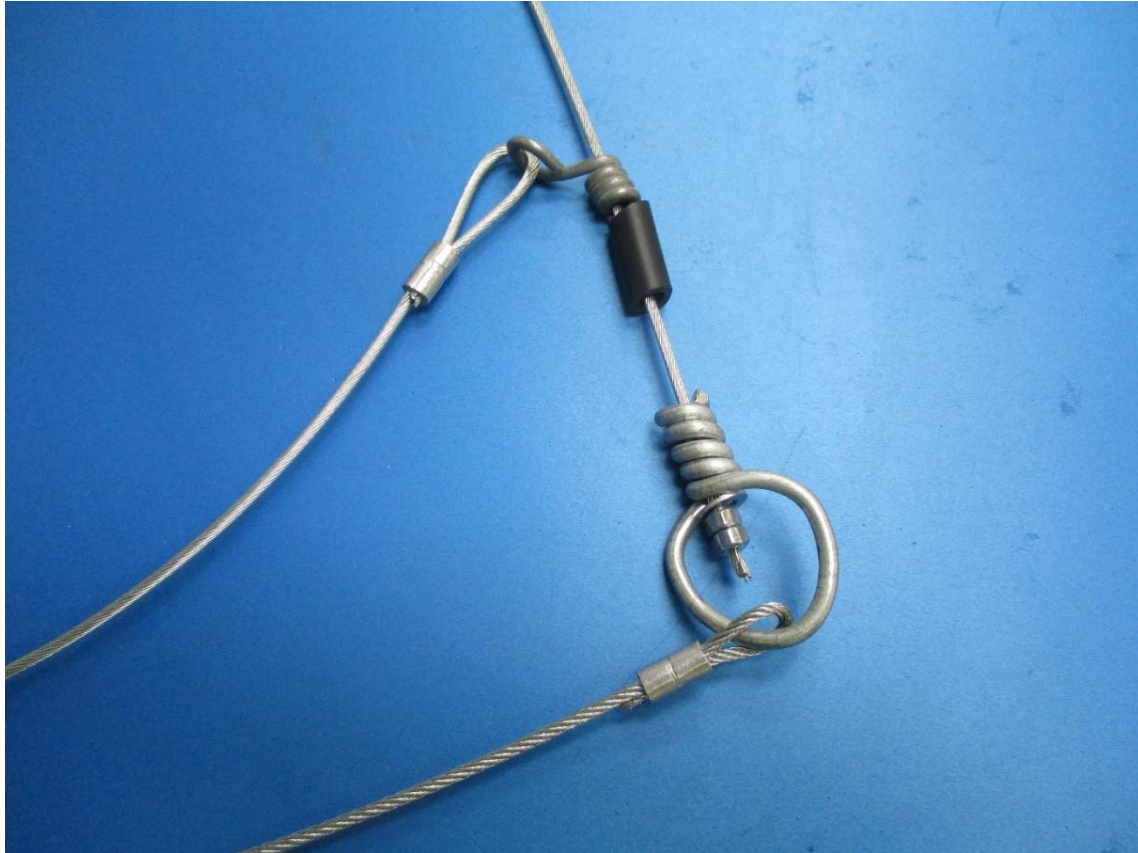
**Figure 4.3:** Detailed view on the centre swivel (middle right), and assumed breakaway weak link (top) on the sample supplied for testing. Note that the snare loop and lower securing section of wire rope are of different construction.

The wire ropes were both  $\varnothing 2$  mm, but were of different construction, presumably designed with the correct operation (required flexibility etc.) of the snare in mind.

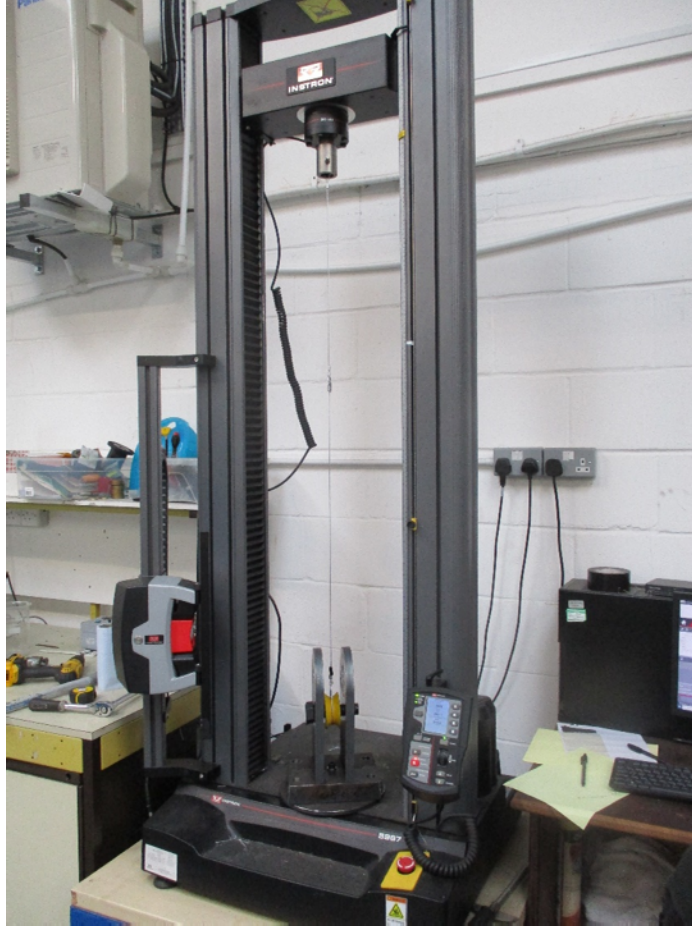
**Figure 5.1:** INSTRON tensile testing machine with breakaway snare mounted ready for testing.

After some initial trials, testing was undertaken in **TTI Testing's** INSTRON 5967 tensile testing machine using the 30 kN load cell, a calibration certificate for which is presented in Appendix A.

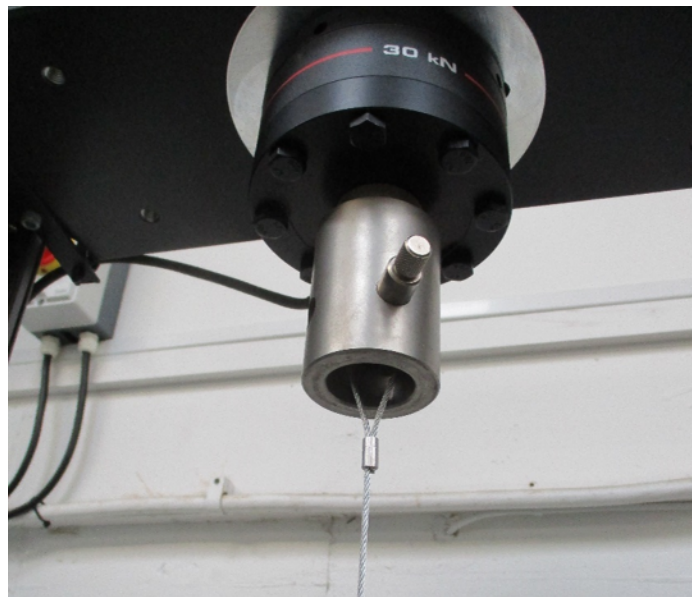
**Figure 5.2:** Ground eye loop mounted on the 30 kN load cell by  $\text{Ø}1/2$ " steel pin.

In the first instance, the whole snare assembly was tested, secured at one end through the ground eye loop by a  $\varnothing\frac{1}{2}$ " pin (Figure 5.2). At the other end of the assembly, the loop at the end of the snare was mounted on a plastic spool ( $\varnothing 67$  mm), Figure 5.3, which was intended to approximate to the diameter of an animal's neck.

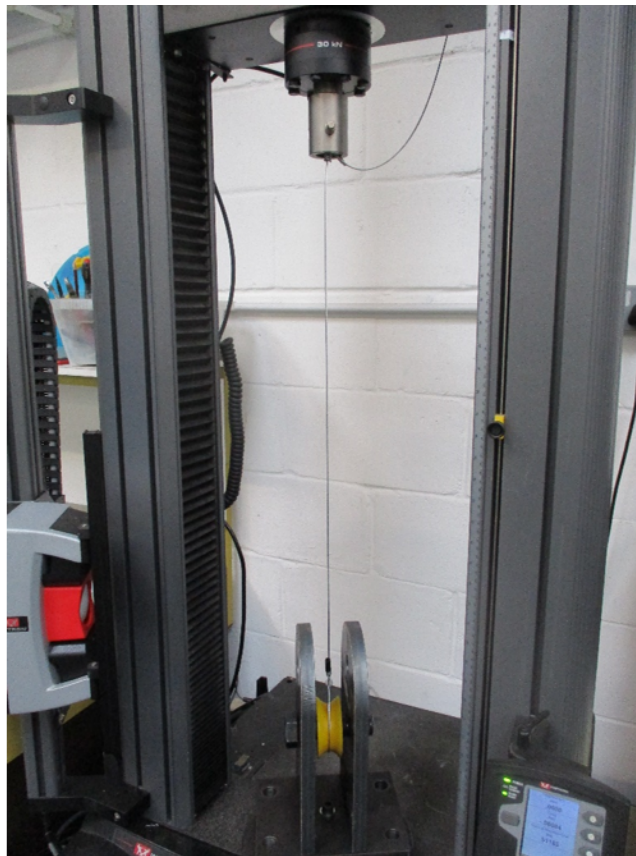
**Figure 7.1:** Showing the arrangement employed to test the sub-assembly strength (Test 3A). The bottom arrangement is as before and the swivel is mounted in the top fitting.

The samples were then returned to the test machine, this time mounting between the centre swivel and snare loop in an attempt to measure the force required to break the weak link (Figure 7.1). In one test the centre swivel pulled off the snare loop wire, whilst in the other two tests the weak link failed, at an average load of 972 N or 99.1 kgf.

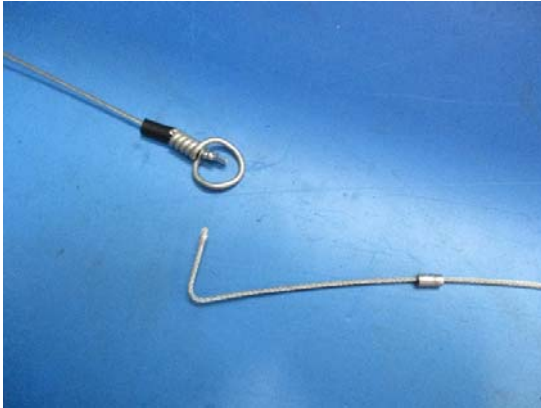
The first point to note is that in all cases, when testing the whole assembly, that the snare did not fail at the “weak link”, instead in each case breaking at the swaged eye loops on the ground wire. An average failure load of 615 N or 62.7 kgf was measured.

Test 1 – eye loop pulled out of swaged fitting at centre swivel

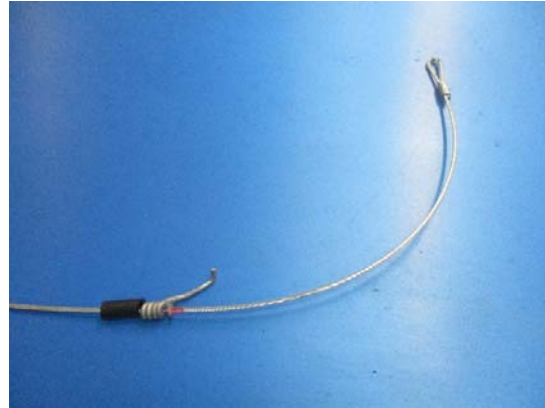
Test 1A – failure of weak link

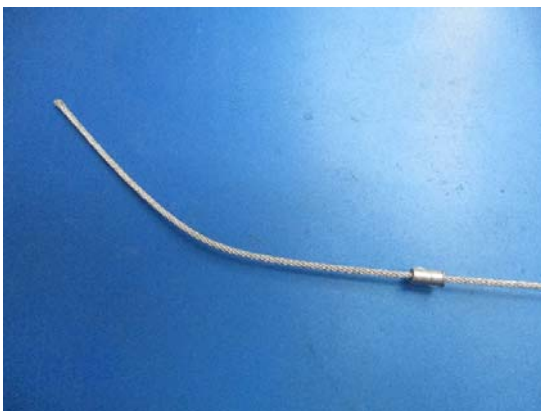
Test 3 – failure of ground eye loop swage

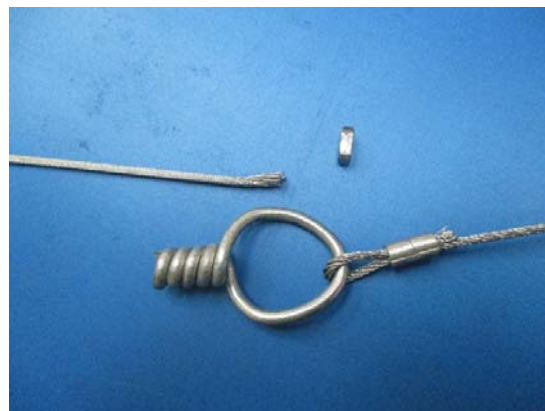
Test 3A – failure of centre swivel swage (note one clip and the washer were lost when the sample failed).
